With the firmware update V2.4.31, the MAVOWATT devices achieve conformity according to IEC 61000-4-30 Edition 3.

Important: For devices manufactured before November 2018 an additional hardware change is necessary (see FAQ's below).

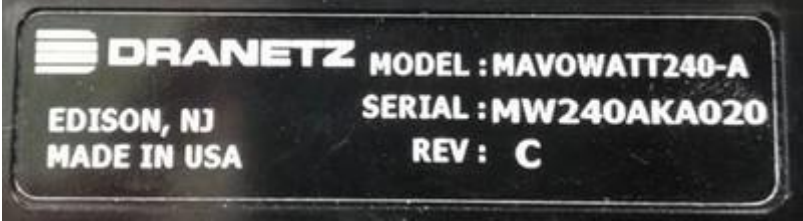
FAQ	Answer
Customer benefit through firmware update?	IEC 61000-4-30 Ed. 3 compliant, faster operation, optimized user guidance
Which devices only need an FW update?	Devices with a production date after November 2018. For devices with an earlier production date a hardware update is also necessary!
What hardware changes are necessary?	<p>To meet the requirements of Ed. 3 a clock module must be exchanged (background: time synchronization). The corresponding hardware replacement is carried out by GMC-I Service GmbH. The costs for this, including recalibration, amount to 1356.- € (Article number QU041). Valid from 1 January 2025</p> <p>Without recalibration the costs amount to 841.- € (Article number QU040). Valid from 1 January 2025</p> <p>Note: The hardware replacement is carried out at the factory, so that lead times of approx. 4 weeks are possible.</p>
How can you tell if a hardware update is required?	The revision number (REV:) indicates whether a hardware update is necessary. For revisions I or earlier, a hardware update must be performed.

FAQ	Answer
	<p>Example: REV: C</p>
